CAPSULE SUMMARY - RICHARDSON BARN (CT-1033)

Maryland Historical Trust State Historic Sites Inventory Form

and/or common Richardson Barn

Survey No. CT-1033

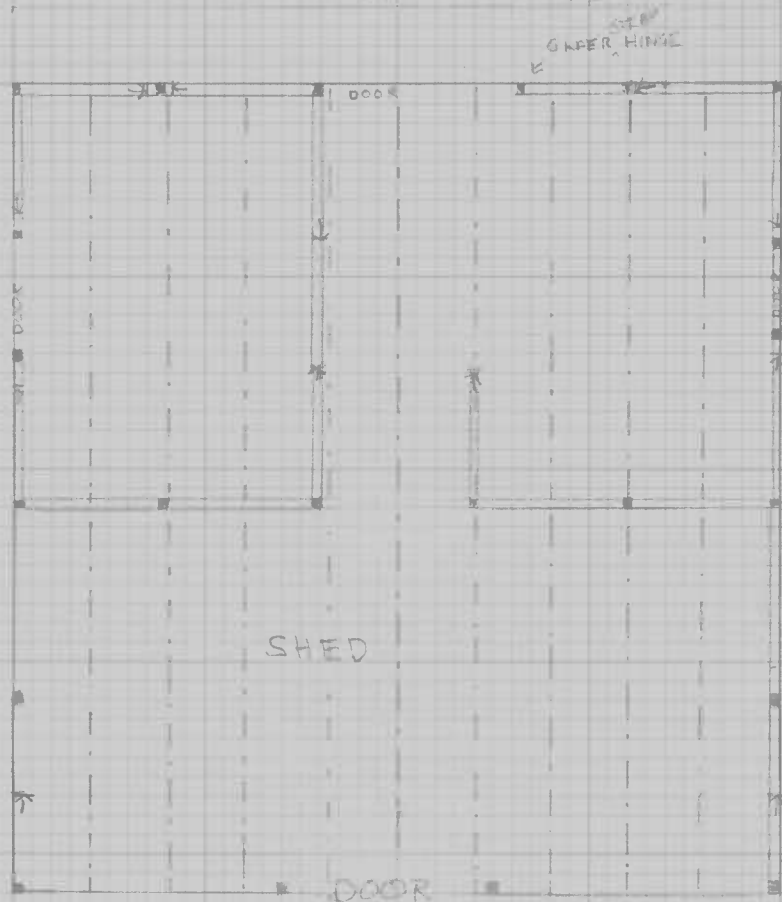
2/22/90 SCALE 1"=10' TW RICHARDSON BARN #2004

S side of barn
N side of barn
N side of shed

East side of barn
West side of barn
East side of shed
West side of shed
